<b>Bulletin Number:</b>	TSB 0031-01
<b>Release Date:</b>	7-May-2024
<b>Effective Date:</b>	7-May-2024
<b>Supersedes:</b>	none
<b>Completion Date:</b>	26-May-2025

# Service Bulletin

<b>Manufacturer:</b>	Head Rush Technologies
<b>Affected Production Dates:</b>	1-Nov-2022 through 26-Feb-2024
<b>Product Names:</b>	TRUBLUE iQ LT (12.5m); TRUBLUE iQ XL (20m); TRUBLUE iQ+ LT (12.5m); TRUBLUE iQ+ XL (20m)
<b>Affected Serial Numbers:</b>	iQ0014492 through iQ0036407 iQXL01283 through iQXL02678 iQP00110 through iQP00161 iQP000164 through iQP000356 iQXLP0104 through iQXLP0182
<b>Model Numbers:</b>	TBiQ-LT; TBiQ-XL; TBiQ+LT; TBiQ+XL

## Abstract of Issue

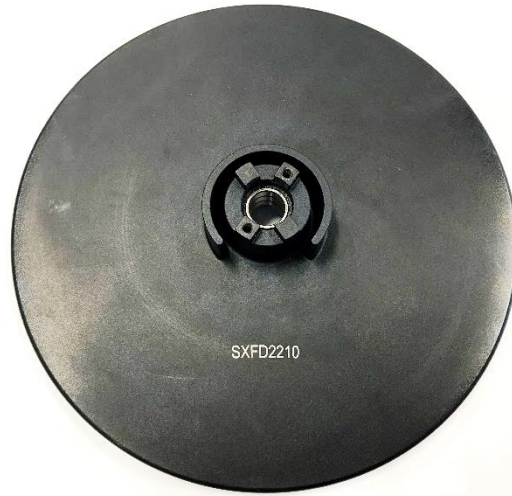
SXFD2210

In TRUBLUE iQ devices within the affected serial number range, a component has been found to cause impaired retraction on devices mounted below certain mounting heights. The component can be identified by manufacturing markings on the Planet Carrier (Part No 12490). If the Planet Carrier marking matches the [Planet Carrier Identification and Instruction Table](#), an Arbor Support component must be added to the assembly. The purpose of the Arbor Support component is to withstand the compressive forces that are applied to the arbor by the webbing during normal use. No other components need to be changed or replaced as part of this Service Bulletin.

\*Marking located opposite the Gear Side

Install the **Half Height** Arbor Support  
(Part No 13153)

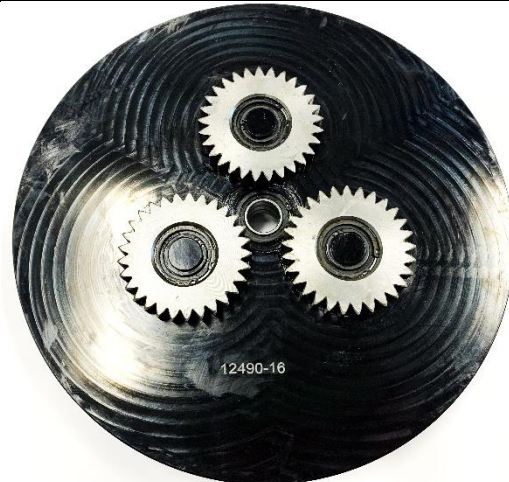
12490-16

\*Marking located on the Gear Side

Install the **Full Height** Arbor Support  
(Part No 13152)

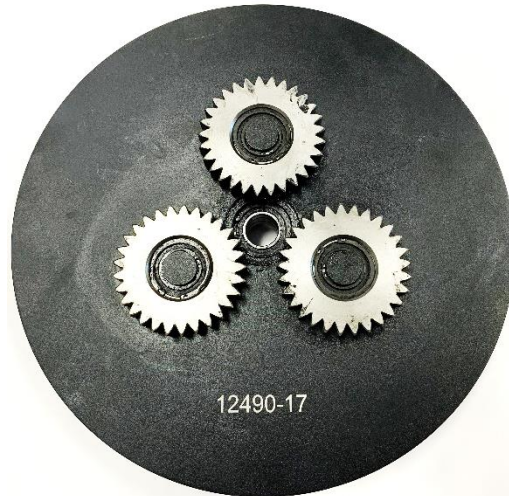
12490-17

\*Marking located on the Gear Side

**Note: Planet Carriers marked with  
12490-17DA; 12490-17FB; 12490-17FA  
do not need any further action and are  
OK for continued use.**

Install the **Half Height** Arbor Support  
(Part No 13153)

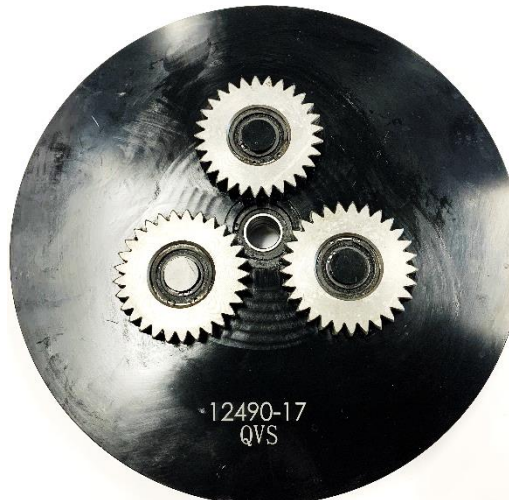
12490-17  
QVS

\*Marking located on the Gear Side

Install the **Full Height** Arbor Support  
(Part No 13152)

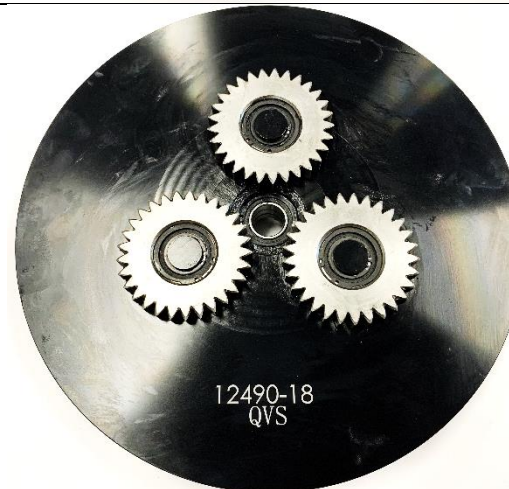
12490-18  
QVS

\*Marking located on the Gear Side

Install the **Half Height** Arbor Support  
(Part No 13153)
