<b>Bulletin Number:</b>	TSB 0031-01
<b>Release Date:</b>	7-May-2024
<b>Effective Date:</b>	7-May-2024
<b>Supersedes:</b>	none
<b>Completion Date:</b>	26-May-2025

# Service Bulletin

<b>Manufacturer:</b>	Head Rush Technologies
<b>Affected Production Dates:</b>	1-Nov-2022 through 26-Feb-2024
<b>Product Names:</b>	TRUBLUE iQ LT (12.5m); TRUBLUE iQ XL (20m); TRUBLUE iQ+ LT (12.5m); TRUBLUE iQ+ XL (20m)
<b>Affected Serial Numbers:</b>	iQ0014492 through iQ0036407 iQXL01283 through iQXL02678 iQP00110 through iQP00161 iQP000164 through iQP000356 iQXLP0104 through iQXLP0182
<b>Model Numbers:</b>	TBiQ-LT; TBiQ-XL; TBiQ+LT; TBiQ+XL

## Abstract of Issue

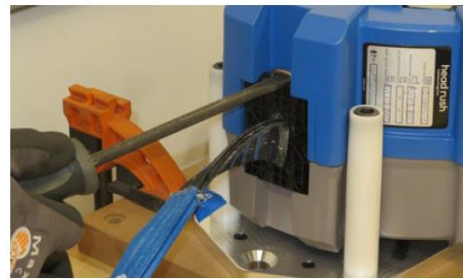
29. Use a standard (flat) medium screwdriver and lift up on the Nozzle Clip. Take care not to scratch the Housing.

1. Disassemble the device beginning on Step 29 of Section 5.7.5 “Rotor Housing Side”

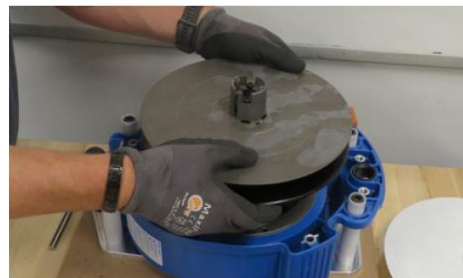
22. Remove the Spring Hub Plate, Short Webbing Loop and Planet Carrier assembly. This entire assembly should slide up and off the Sun Shaft. If the assembly does not slide up easily see [10.9 Remove Stuck Planet Carrier](#) in the [Unscheduled Service Procedures](#).

2. Continue following the Service Manual for disassembly through Step 22 of Section 5.7.6 “Spring Housing Side”
